Effectiveness of Streambank-Stabilization Techniques Along the Kenai River, Alaska

Water-Resources Investigations Report 99-4156

By Joseph M. Dorava

U.S. GEOLOGICAL SURVEY

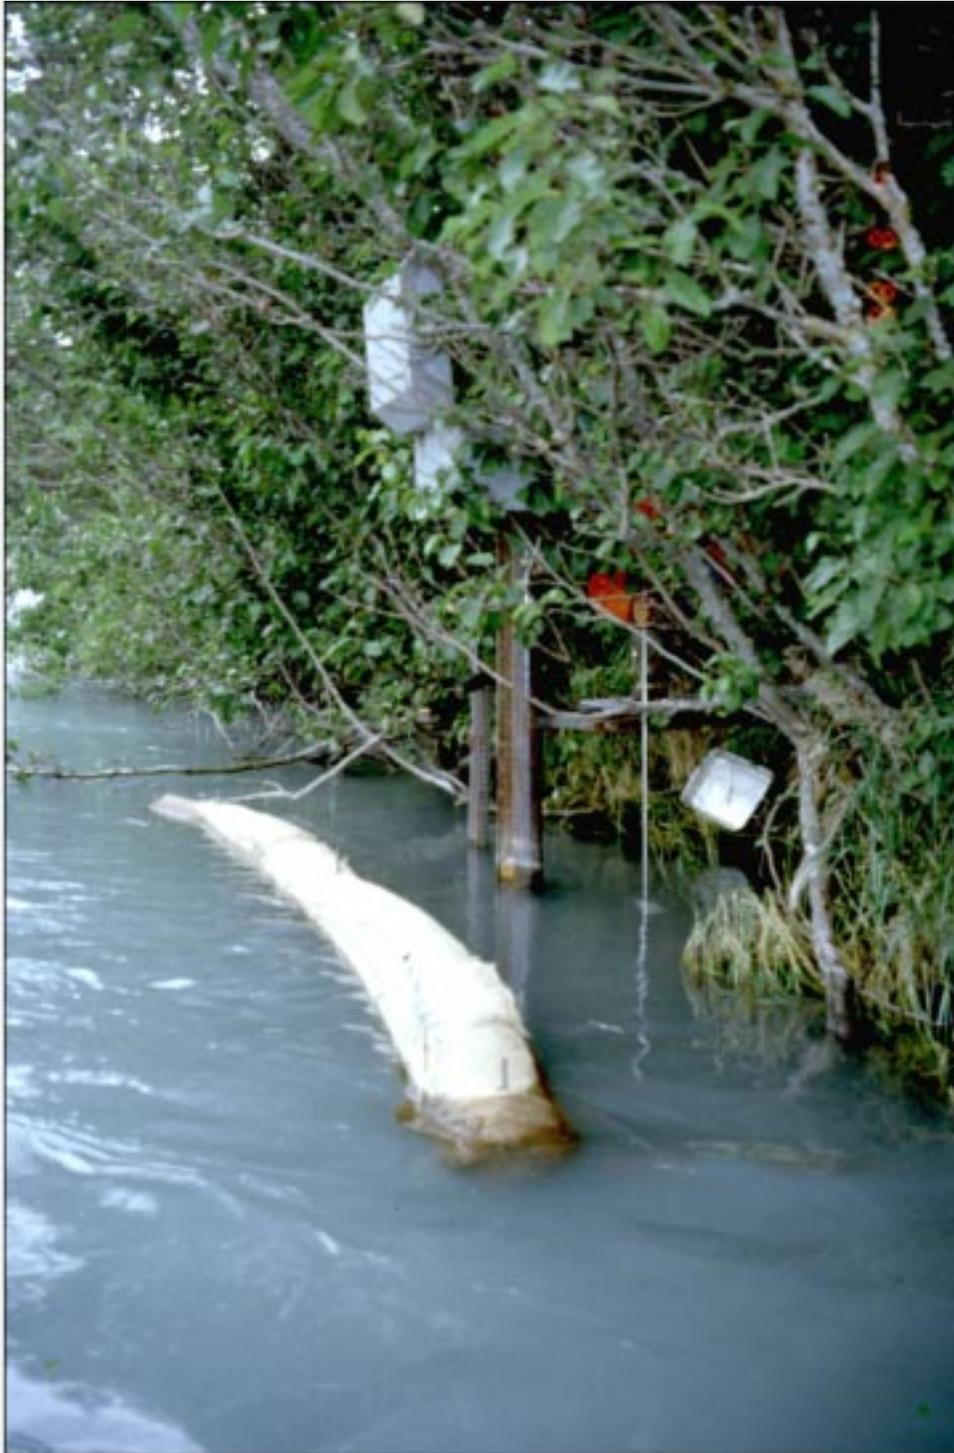
Figure 3. Bio-log installed near river mile 16, Kenai River, Alaska.

period was close to mean annual high-water conditions. The bio-log, about 20 feet long and 12 inches in diameter, was installed in front of the bank by pinning it to the stream bottom with metal stakes (fig. 3). The bio-log protruded about 3 inches above the waterline. Two freshly

Following the test on the natural bank, the bio-log was installed in front of the bank (fig. 3). This bio-log was not a typical bio-log installation, but rather was intended to simulate the effect the bio-log would have on boatwakes. Boatwakes approaching the bank struck the bio-log prior to striking the bank or being recorded by the wake gage. After this test, the bio-log was replaced by the cabled spruce trees (fig. 4). Boatwakes struck the spruce trees prior to the wake-gage or the streambank. The average of the 20 recorded maximum wake heights was calculated and used to compare the natural bank with the same bank after installing the bio-log and the cabled spruce trees (fig. 7, table 1).

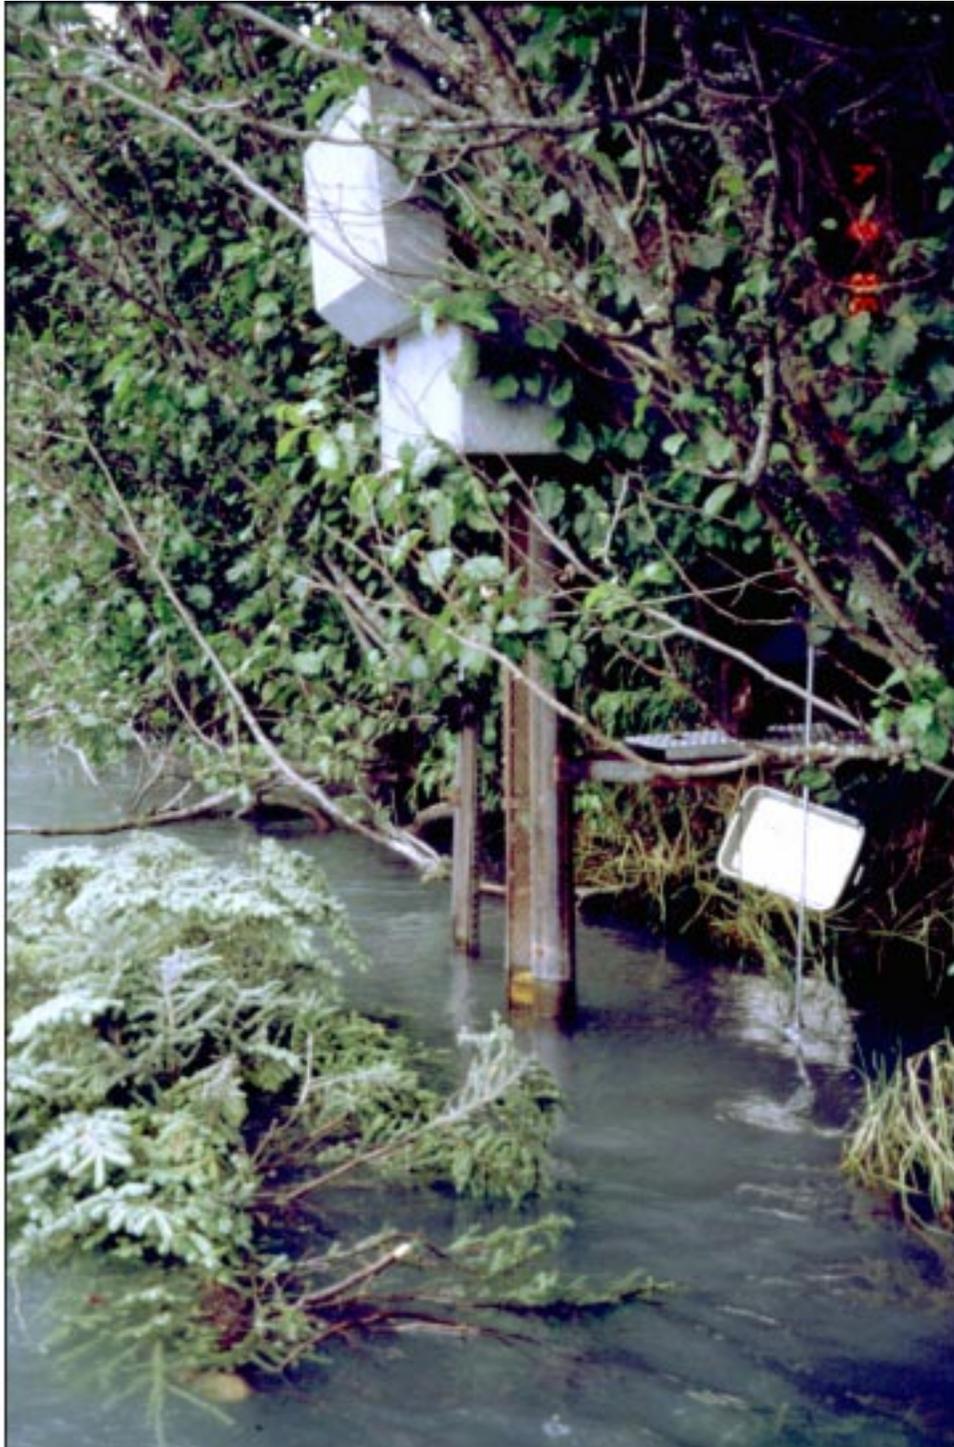
Figure 4. Spruce trees cabled to streambank near river mile 16, Kenai River, Alaska.

cut spruce trees about 20 feet long were cabled together and attached to the streambank with short cables (fig. 4). The spruce trees extended above the water line and into the river considerably more than the bio-log.

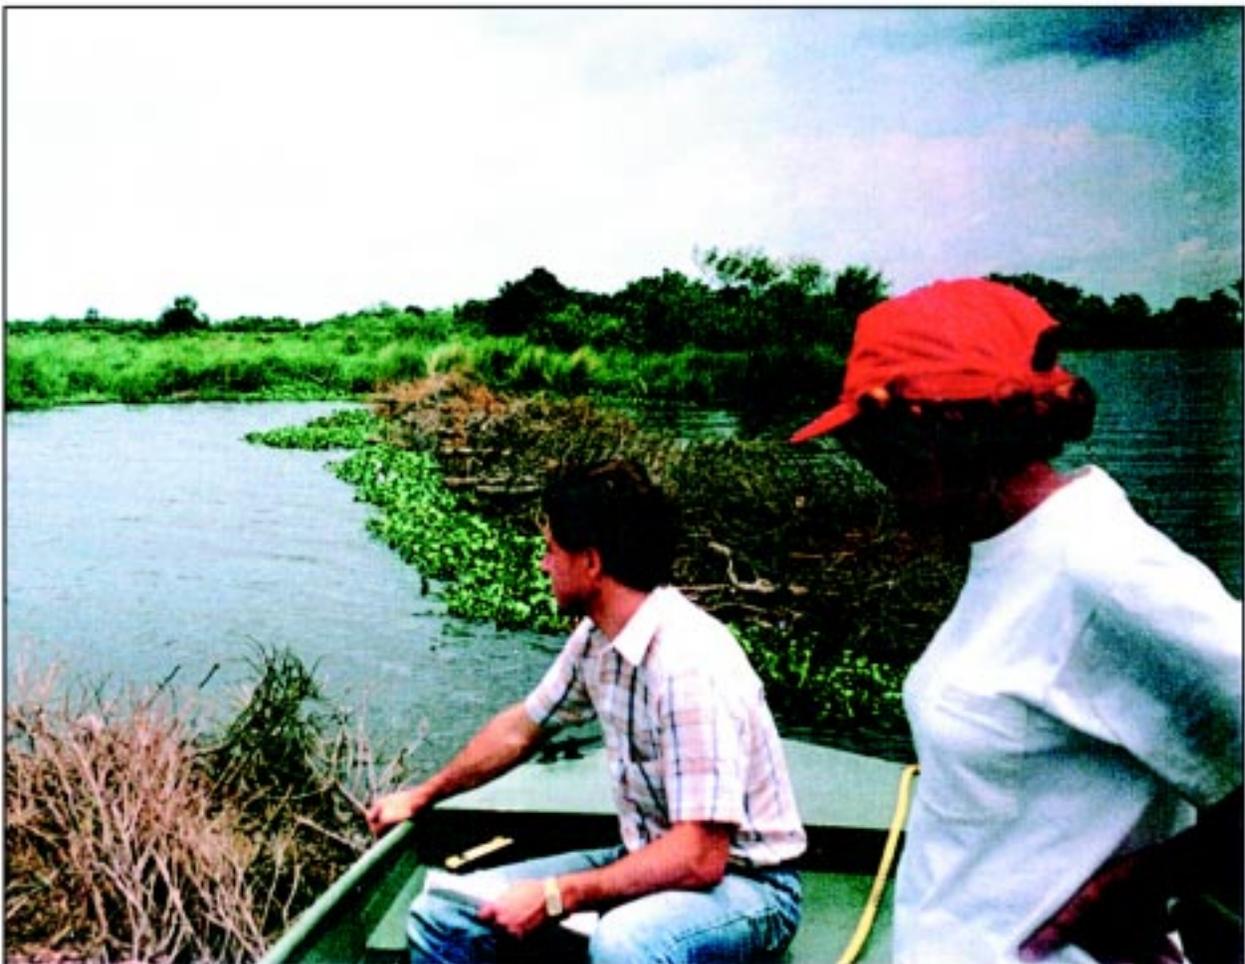
Figure 10. Christmas trees being used as shoreline erosion control in Louisiana (photograph courtesy of Louisiana Department of Natural Resources).

Bio-logs are a relatively new erosion control technique, whereas the low-cost erosion reduction provided by spruce trees has been recognized for some time. An illustrative example is the use of Christmas trees as erosion control along the coastline of Louisiana (Bahlinger, 1996; Dunne, 1999) (fig. 10).
