MAP SHOWING LOCATION OF GLACIERS, GLACIER-DAMMED LAKES, GLACIER-SHEATHED VOLCANOES AND AREAS SUBJECT TO OUTBURST FLOODING IN SOUTHEASTERN ALASKA

GLACIER DAMMED LAKES AND OUTBURST FLOODS IN ALASKA

By  
Austin Post and Lawrence R. Mayo  
1971

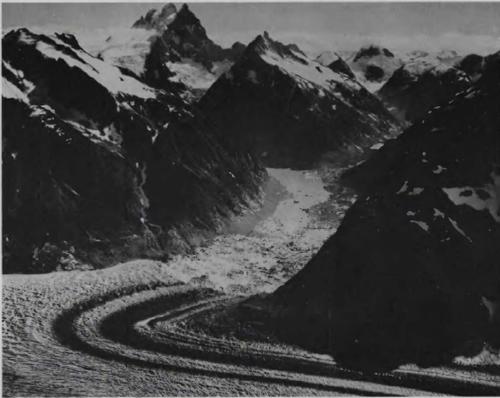
TULSEQUAH LAKE NEARLY DRAINED BY AN OUTBURST FLOOD

TULSEQUAH LAKE (NO. 5) COAST MOUNTAINS LOCATED JUST EAST OF THE INTERNATIONAL BOUNDARY IN CANADA. THIS LAKE GENERALLY DRAINS CATASTROPHICALLY IN LATE SUMMER. THE RESULTING FLOODS MOVE DOWN THE TAKU RIVER VALLEY WHERE A HIGHWAY CONNECTION TO JUNEAU HAS BEEN PROPOSED.

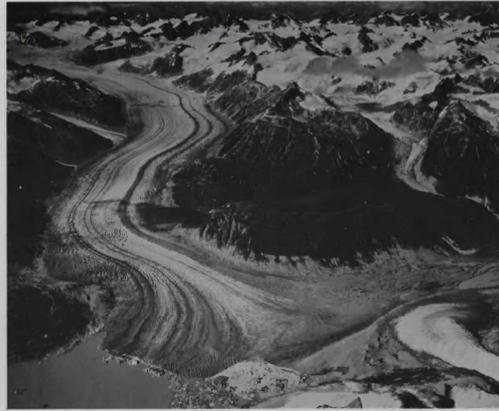
SUMMIT LAKE FILLED TO NEAR MAXIMUM LEVEL

SUMMIT LAKE (NO. 30) WHICH IS DAMMED BY AN UNNAMED GLACIER IN THE CHIGNAI MOUNTAINS. THIS PHOTOGRAPH, TAKEN IN AUGUST 1963 SHOWS THE LAKE NEAR ITS MAXIMUM LEVEL AND ICEBERGS ARE BEING DISCHARGED FROM THE GLACIER MARGIN.

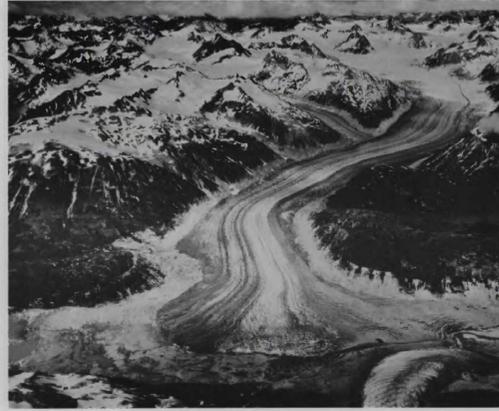
SUMMIT LAKE ALMOST COMPLETELY DRAINED

SUMMIT LAKE (NO. 30) PHOTOGRAPHED IN AUGUST 1970. THE LAKE HAS DRAINED THROUGH A SUBGLACIAL CHANNEL TO NORTH FORK BIG RIVER (RIGHT). THIS GLACIER HAS BEEN RETREATING FOR MANY YEARS. THE PRESENT ICE DAM WILL COMPLETELY FAIL IF RETREAT CONTINUES FOR A FEW MORE DECADES.

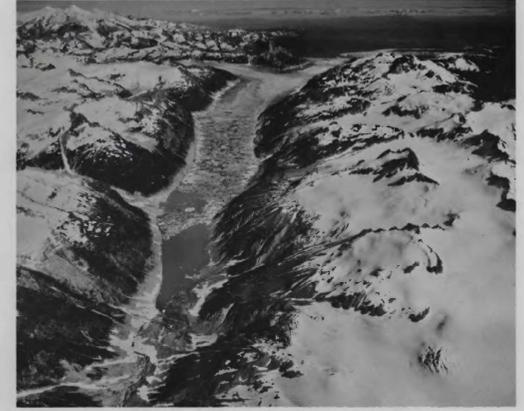
BLOCKADE LAKE IN THE PROCESS OF REFILLING

BLOCKADE LAKE (NO. 31) CHIGNAI MOUNTAINS. THIS LAKE IS IMPOUNDED BEHIND A MASSIVE ICE DAM 15.2 KILOMETERS (9.5 MILES) IN LENGTH FORMED WHERE BLOCKADE GLACIER LATERALLY ENTERS A DEEP, NARROW VALLEY AT THE FAR END OF THE LAKE. ALTHOUGH THE MAJOR FLOW OF ICE IS TO THE EASTERN TERMINUS, A PORTION OF THE ICE FLOWS TOWARD THE LAKE TERMINATING IN AN ICE CLIFF FROM WHICH LARGE ICEBERGS ARE DISCHARGED. THIS LAKE DOES NOT DUMP ANNUALLY BUT LARGE CHANGES IN SURFACE LEVEL INDICATE THAT THE ICE DAM FAILS EVERY FEW YEARS CAUSING MAJOR FLOODS ON MCARTHUR RIVER.

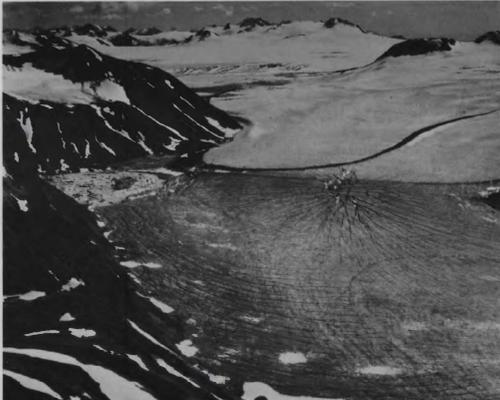
SKILAK GLACIER—SHOWING LATERAL AND SUBGLACIAL LAKES

THIS ICE DAMMED LAKE (NO. 27) IS LOCATED IN AN EMBAYMENT BETWEEN SKILAK GLACIER AND AN UNNAMED GLACIER IN THE KENAI MOUNTAINS. AN EXPOSED LAKE CAN BE SEEN ON THE LEFT. THE RADIAL PATTERN OF CREVASSES IN THE CENTER OF THE GLACIER SUGGESTS THAT THIS ICE IS RAISED AND LOWERED BY ALTERNATE FILLING AND DRAINING OF A SUBGLACIAL LAKE. WATER FROM THIS LAKE CREATED A DEVASTATING FLOOD IN THE KENAI RIVER VALLEY IN JANUARY 1969.

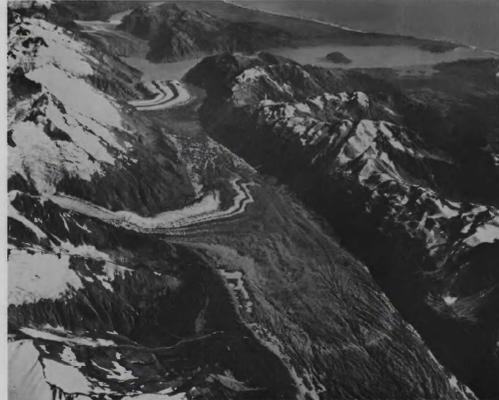
DESOLATION VALLEY—FORMATION AND EVOLUTION OF TWO LAKES

TWO LARGE ICE DAMMED LAKES ARE IN THE PROCESS OF FORMATION IN DESOLATION VALLEY, FAIRWEATHER RANGE. IN THE FOREGROUND IS DEBRIS COVERED ICE WITH SEVERAL LARGE, CONCENTRIC AND CONCENTRIC CREVASSES WHICH ARE ATTRIBUTED TO RAISING AND LOWERING OF THE ICE DUE TO FLOATING. WATER IS VISIBLE ALONG THE MARGINS AND IN THE LARGER CREVASSES. BETWEEN DESOLATION AND LUTUYA GLACIERS (UPPER CENTER) THE ICE HAS RECENTLY BROKEN UP AND A LARGE LAKE (NO. 9) IS NOW CLEARLY VISIBLE. THE LAKE PARTIALLY DRAINS SUBGLACIALLY AT INTERVALS TO LUTUYA BAY (MIDDLE DISTANCE). THE RECENT FORMATION OF THESE LAKES IS DUE TO THINNING OF THE GLACIERS OCCUPYING THE VALLEY.

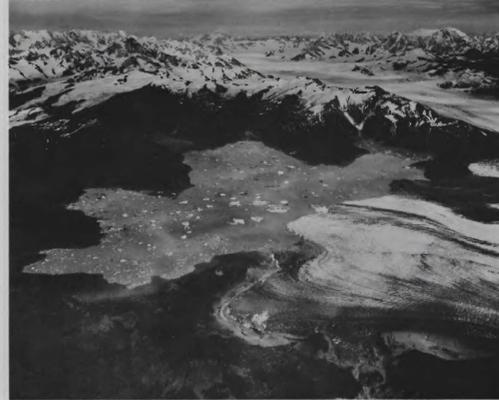
BERG LAKE—A RECENTLY DEVELOPED HAZARDOUS SITUATION

BERG LAKE (NO. 14) NEAR KATALIA. RETREAT OF AN ARM OF BERING GLACIER WHICH IN 1905 FILLED MOST OF THIS LARGE EMBAYMENT HAS JOINED FIVE SEPARATE LAKES THAT OCCUPIED INDIVIDUAL BAYS OF THE PRESENT LAKE. LOWERING OF THE ICE DAM IF CONTINUED WILL ALMOST CERTAINLY LEAD TO THE RELEASE OF IMMENSE FLOODS IN THE NEAR FUTURE. THE BERING RIVER FLOOD PLAIN AND AREA SURROUNDING BERG LAKE ARE ENDANGERED BY THIS INCREASINGLY CRITICAL SITUATION.

Bering River	14	Berg Lake	28 11	Bering	Bering River, Bering Lake	The lake is presently melting over a bedrock saddle. Retreat of Bering Glacier has greatly increased the size of this lake and recently created an extreme flood hazard on Bering River lowlands. Monitoring is recommended.	Map, Bering (C-7 and C-8), Alaska; Balvin (1963); Post (1967, table 5); Ragle, Sizer and Field (1965a, p. 18, 19, 24-27, 30); Stone (1963a); U. S. Geological Survey gaging stations 15-2020 and 2120	31	Blockade Lake	19 7.4	Blockade	McArthur River	Lake drains subglacially every few years. Outburst history is unrecorded. Extreme flood hazard along McArthur River lowlands. Collecting data on future floods is recommended.	Map, Kenai (D-7), Alaska			
Copper River	15	Iceberg Lake	1.8 7	Tazlina	Tazlina Glacier outwash plain, Tazlina Lake	Two lakes drain subglacially and created a flood dumped at the same time resulting in the highest measured flood on the Tazlina River. Strandline above Iceberg Lake indicate that the lake has been about 100 meters (300 feet) higher in recent decades. Extreme flood hazard in Tazlina lowlands, moderate flood hazard in Copper River valley. Monitoring is recommended. (See lake No. 10.)	Map, Valdez (C-8), Alaska; Post (1967, table 5); Ragle, Sizer and Field (1965a, p. 18, 19, 24-27, 30); Stone (1963a); U. S. Geological Survey gaging station 15-2120	32	Summit Lake	4.7 1.8	Unnamed	North Fork, Big River	Lake drains subglacially. Basin has increased considerably in size from 1954 to 1970 as a result of recession of the glacier. Moderate to extreme flood hazard on Big River lowlands. Collecting data on future floods is recommended.	Map, Kenai (D-8), Alaska

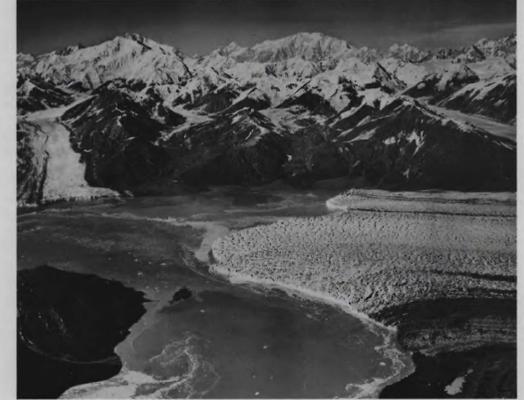
RUSSELL FIORD—SITE OF A LARGE POTENTIAL LAKE

DISENCHANTMENT BAY AND RUSSELL FIORD (NO. 13) NEAR YAKUTAT. THE MASSIVE HUBBARD GLACIER, DRAINING AN AREA OF APPROXIMATELY 4,000 SQUARE KILOMETERS (1,550 SQUARE MILES) DISCHARGES INNUMERABLE ICEBERGS INTO THE BAY FROM AN ICE CLIFF NEARLY 100 METERS (300 FEET) HIGH AND 10 KILOMETERS (6 MILES) LONG. THE GLACIER HAS BEEN SLOWLY ADVANCING SINCE IT WAS MAPPED IN 1895. IF THE ADVANCE CONTINUES AT THE SAME RATE, IN A FEW DECADES THE GLACIER WILL CLOSE OFF RUSSELL FIORD (FOREGROUND) TURNING THIS ARM OF THE SEA INTO A LAKE 230 SQUARE KILOMETERS (90 SQUARE MILES) IN AREA.

Yakutat Bay	13	Russell Flood at present time	200 100	Hubbard	Would drain directly to Dismal-champlain Bay under or along margin of glacier	Hubbard Glacier has advanced intermittently since mapped in 1895. The glacier will close off the entrance to Russell Flood in about 20 years if the present average rate of advance continues. No present flood hazard but extreme danger to boats near glacier margin and in tidal currents at mouth of flood.	Map, Mt. St. Elias, 1:250,000, Alaska; Map, International Boundary Commission, Sheet U. S. 1195; Tarr and Martin (1914, p. 108-109, pl. 36, map 3)	30	McArthur Lake	72 28	Barrier	Chukachina Lake	Lake outlet is located along margin of the nearly stagnant terminus of Barrier Glacier. Small movements in this ice have caused rises in the lake level (Gordon Giles, written commun., 1967) and has resulted in changing stage-discharge relationships at the river gage located at Barrier Glacier. These changes have been relatively slow and no outburst floods are expected unless the glacier advances strongly. Very low flood hazard from lake. Floods resulting from glacier melt from volcanic eruptions of Mount St. Marys may present serious hazards on Chukachina River.	Map, Kenai (D-7), Alaska

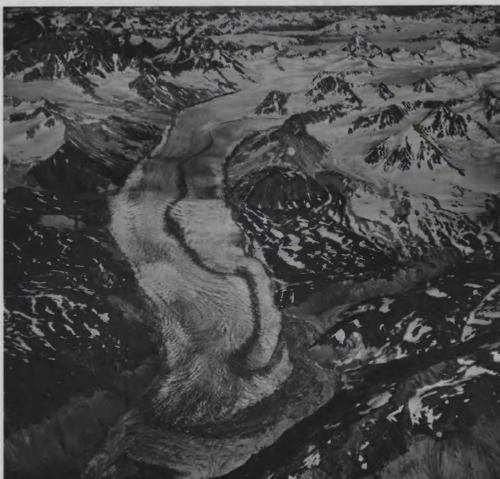
TIKKE GLACIER AT BEGINNING OF SURGE

TIKKE GLACIER, LOCATED IN CANADA NORTH OF GLACIER BAY IS SUBJECT TO PERIODIC SURGES IN WHICH THE ICE SUDDENLY ADVANCES SEVERAL KILOMETERS AT APPROXIMATELY 20-YEAR INTERVALS. THIS VIEW OF THE GLACIER WAS TAKEN IN AUGUST 1962 WHEN A SURGE WAS MOVING RAPIDLY DOWN THE GLACIER. LATERAL VALLEYS TO THE RIGHT OF THE GLACIER DO NOT CONTAIN LAKES. FURTHER UP GLACIER ON THE LEFT SIDE THE FAST-MOVING ICE RECENTLY HAS DAMMED THE LATERAL STREAM.

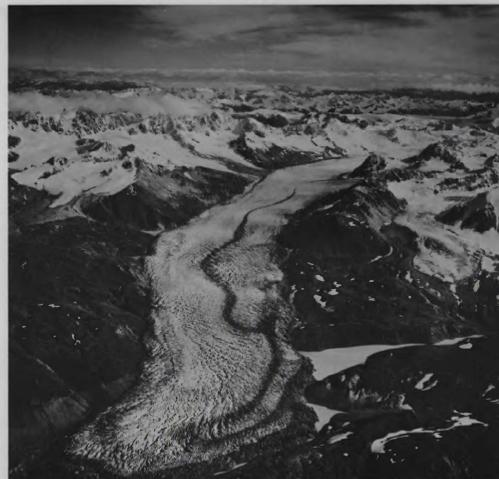
TIKKE GLACIER AFTER SURGE

TIKKE GLACIER IN AUGUST 1968 AFTER THE CULMINATION OF THE SURGE SHOWN IN PROGRESS IN THE VIEW TO THE LEFT. THE ADVANCING ICE HAS NOW FORMED DAMS BLOCKING BOTH SIDE VALLEYS ON THE RIGHT SIDE OF THE GLACIER. SINCE COMPLETING ITS RAPID MOVEMENT, THE GLACIER WAS RELIEVED INTO NEAR STAGNATION. THE GLACIER DAMMED LAKES PROBABLY WILL FILL AND DUMP ANNUALLY UNTIL MELTING REMOVES THE ICE DAMS. TIKKE GLACIER IS ONLY ONE OF NEARLY 200 SURGING GLACIERS IN ALASKA AND ADJACENT CANADA WHICH CAN BE EXPECTED TO FORM HAZARDOUS LAKES PERIODICALLY.

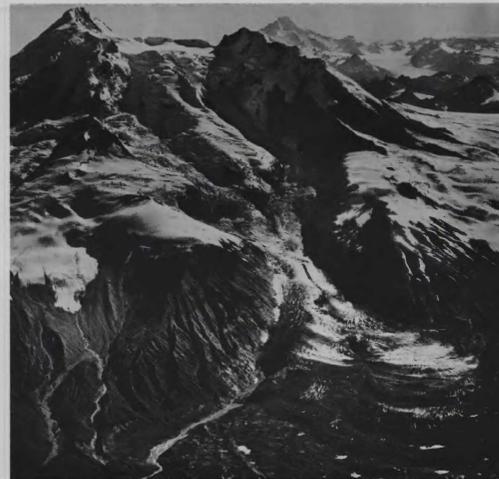
REDOUBT VOLCANO BEFORE 1966 ERUPTION

REDOUBT VOLCANO, CHIGNAI MOUNTAINS. PHOTOGRAPH AUGUST 1963 SHOWING CONDITIONS BEFORE THE ERUPTIONS BEGAN IN JANUARY 1966. THE LARGE UNNAMED GLACIER SHOWN HERE DESCENDS FROM THE SUMMIT CRATER. ALTHOUGH THE GLACIER IS LITTERED BY MUCH DEBRIS ON ITS LOWER REACHES, THE SPECTACULAR ICE CASCADES ON THE MOUNTAIN SLOPES ARE ALMOST DEBRIS FREE, INDICATING RECENT DECADES OF LITTLE VOLCANIC ACTIVITY.

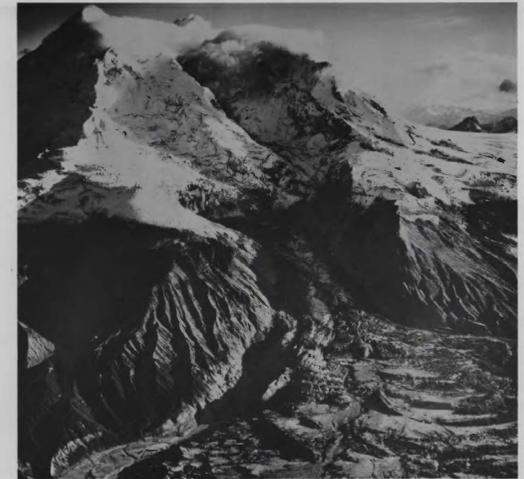
GLACIER ON REDOUBT VOLCANO AFTER ERUPTION

REDOUBT VOLCANO IN AUGUST 1968 SHOWING CHANGES IN THE GLACIER RESULTING FROM THE ERUPTIONS. STEAM CLOUDS FROM THE ACTIVE CRATER STILL OBSCURED THE SUMMIT OF THE MOUNTAIN. THE ICE CASCADES FLOWING FROM THE SUMMIT CRATER HAVE BEEN COMPLETELY DESTROYED AND A LARGE STREAM OF YELLOWISH DEBRIS-LADEN WATER WAS RUSHING DOWN THE GORGE IN ITS PLACE. AERIAL OBSERVATIONS IN 1967 INDICATED LOWERING OF THE GLACIER SURFACE LEVEL IN THE CRATER WHICH SUGGESTS THAT ICE MELT DUE TO VOLCANIC HEAT WAS THE PRINCIPAL SOURCE OF THE FLOOD WATER. THE LOWER GLACIER IS ALMOST COMPLETELY BURIED BY DEBRIS DEPOSITED BY THE FLOOD WATERS.

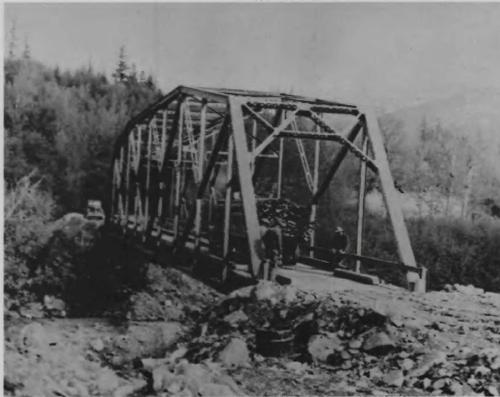
SHEEP CREEK

BRIDGE AT SHEEP CREEK, EAST OF VALDEZ ON THE RICHMOND HIGHWAY. DENSE LOW WILLOW AND ALDER GROWING ON THE FLOOD PLAIN INDICATE SEVERAL YEARS WITHOUT FLOOD ACTIVITY BUT ABSENCE OF LARGE TREES SUGGESTS THAT DAMAGING FLOODS HAD OCCURRED EARLIER. BRIDGE FORMS A CONSTRUCTION IN THE FLOOD PLAIN. ALASKA DEPARTMENT OF HIGHWAYS PHOTOGRAPH. DATE UNKNOWN.

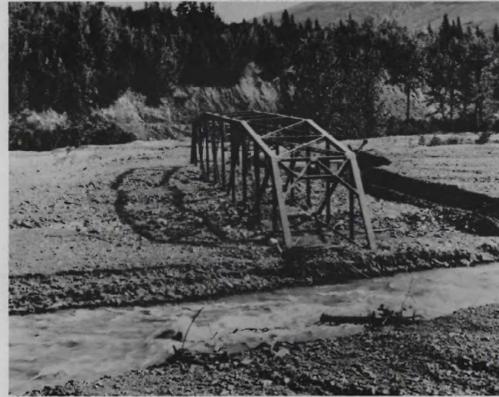
SAME BRIDGE AT SHEEP CREEK PARTIALLY BURIED BY DEBRIS RESULTING FROM A GLACIER OUTBURST FLOOD FROM A THIN GLACIER DAMMED LAKE (NO. 23). SEDIMENT BURIED MUCH OF THE WILLOW AND ALDER BUSHES BUT AS THE FLOOD DID NOT CARRY AWAY THE COTTONWOOD TREES AT THE EDGE OF THE FLOOD PLAIN THIS FLOOD COULD NOT HAVE BEEN OF MUCH GREATER VOLUME THAN PREVIOUS FLOODS. APPROXIMATELY 7.5 METERS (25 FEET) DEPTH OF DEBRIS WAS DEPOSITED AT THE BRIDGE SITE. LARGE-SCALE EROSION UPSTREAM MUST HAVE TAKEN PLACE TO PROVIDE THE FILL MATERIAL. ALASKA DEPARTMENT OF HIGHWAYS PHOTOGRAPH. SEPTEMBER 1945.

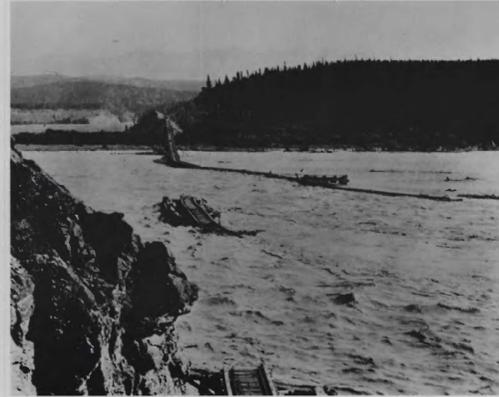
COPPER RIVER AND NORTHWESTERN RAILWAY BRIDGE NEAR CHITNA BEING SWIFT AWAY BY A MAJOR FLOOD WHICH OCCURRED IN AUGUST 1932. GENERALLY CLEAR, BALMY WEATHER PREVAILED AT THE TIME, SO THE FLOOD IS JUDGED TO HAVE BEEN DUE TO A GLACIER DAMMED LAKE OUTBURST, PROBABLY ORIGINATING FROM LAKES DAMMED BY TAZUNA GLACIER. ALASKA DEPARTMENT OF HIGHWAYS PHOTOGRAPH. AUGUST 1932.
